AL SUMELAT  
WATER NETWORK  
VILLAGE OF AL SUMELAT, IRAQ

**SIGIR PA-05-004**  
**MARCH 15, 2006**

## **Al Sumelat Water Network Village of Al Sumelat, Iraq Synopsis**

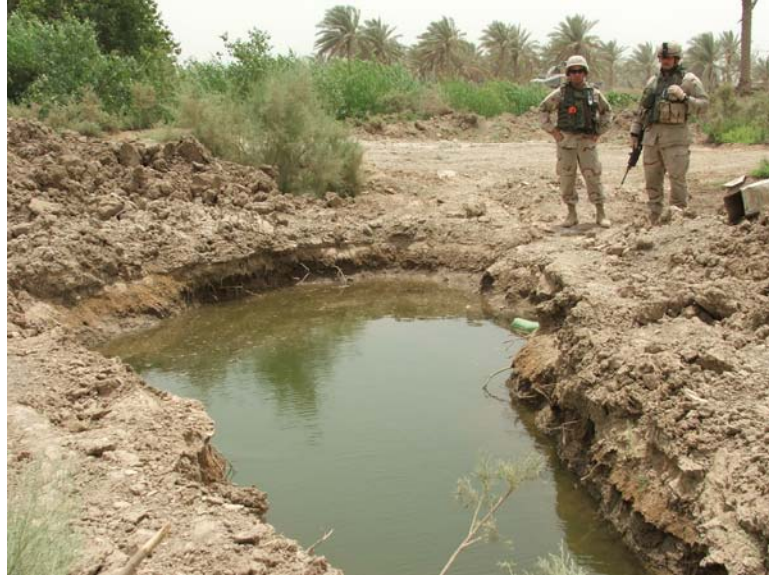
Connect new 250 mm diameter UPVC pipeline to existing 1200 mm water main  
The contract required connecting the new 250 millimeter diameter UPVC pipeline to the existing 1200 millimeter water main. Observations during the site visit could not verify the new connection had been completed. An open excavation was found at the location of the connection (Figure 1, point A). The excavated pit was filled with water (Site photo 1) and piping could not be located beneath the water.

**Site Photo 1: Pipeline point A, showing recent excavation**

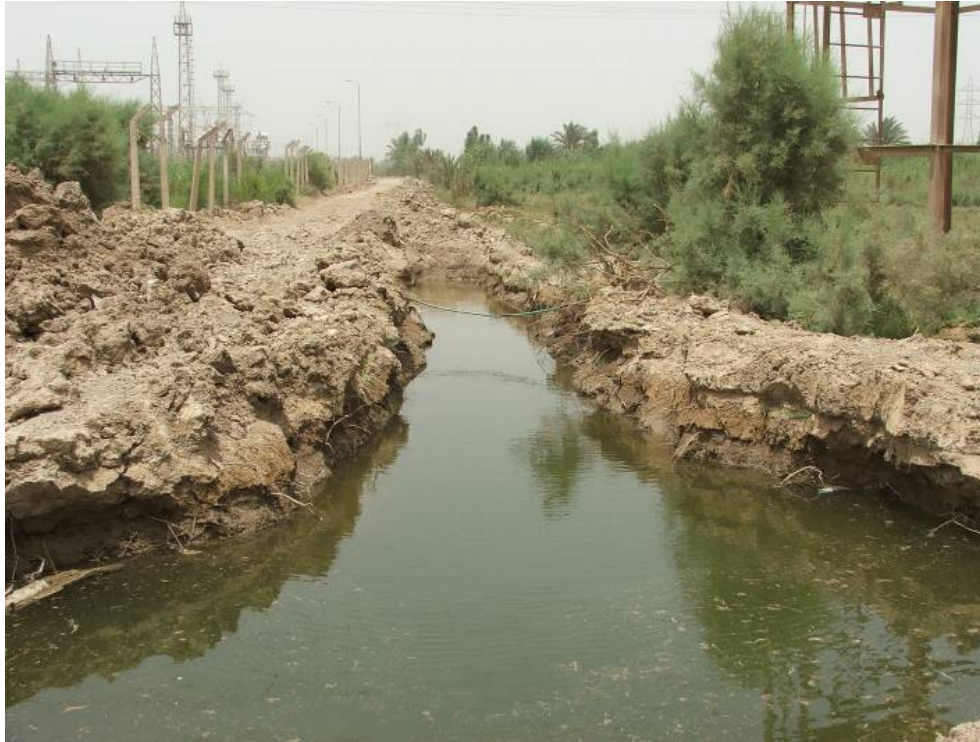
**Point A to B:** The approximate length of the pipeline from point A to point B (see the locator map in Figure 1 on page 4) is 840 meters. Disturbed soil leading in the direction of the pipeline route was observed from point A. The disturbed soil appeared to be the result of a recent trench excavation and subsequent backfilling of the trench (Site photo 2). It could not be determined how far this excavation continued. The starting point of the pipeline was not visibly protruding from the disturbed soils and could not be located at point A. An observation at point B leading back toward point A along the proposed pipeline path was of an open field showing no recently disturbed soil (Site photo 3). Consequently, no evidence that the pipeline had been installed between points A and B was found.

**Site photo 2: Pipeline point A, leading to point B**

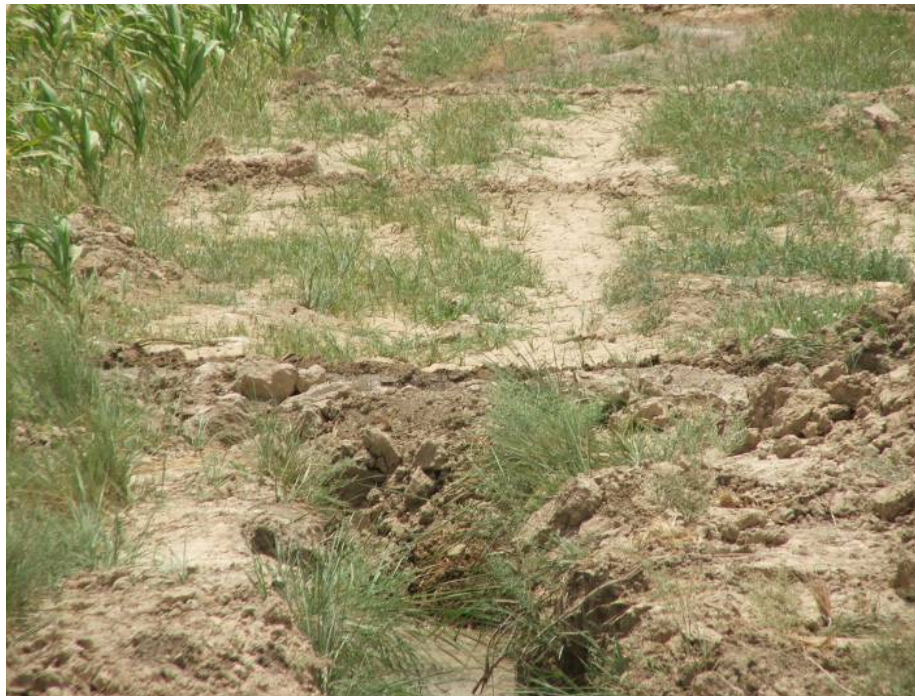
**Site photo 3: Pipeline point B, leading back to point A**

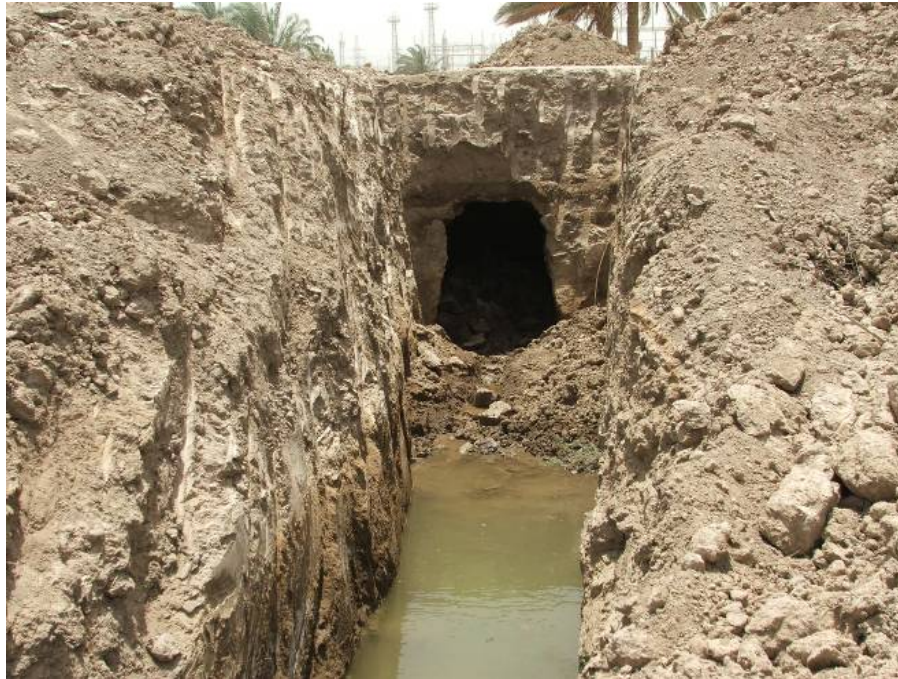
**Point B:** Point B on the locator map in Figure 1 on page 4 is the point at which the pipeline route crosses underneath an irrigation canal. A recently excavated tunnel approximately 1 meter by 1/2 meter was observed underneath the irrigation canal. The pipeline was not visible leading into (Site photo 4) or exiting the

tunnel. The bottom of the tunnel excavation appeared to be undisturbed soil. Consequently, no evidence that the pipeline had been installed beneath the irrigation canal was found.

**Site photo 4: Point B excavated tunnel under irrigation canal**

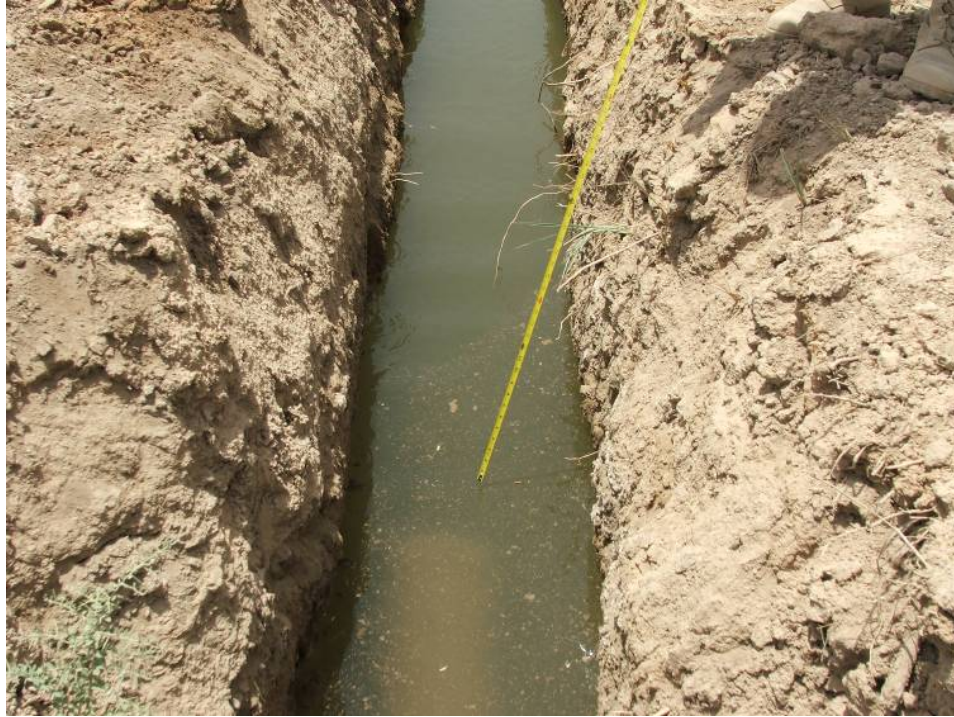
**Point B to C:** The approximate length of the pipeline from point B to point C (see the locator map in Figure 1 on page 4) is 1,495 meters. Uncapped endpoints of the pipeline were observed at both points B and C (Site photos 5 & 6). The pipe diameter looked to be approximately 225 millimeters, but accurate measurements were not obtained at this location. Disturbed surface soil was observed continuously between points B and C along the proposed pipeline route. The disturbed soil appeared to be the result of a recent trench excavation and subsequent backfilling of the trench. A sand base was not present at the endpoints of the pipeline. A significant amount of unconsolidated soil was observed above grade along the pipeline path. Lack of compacting during backfilling operations would result in the presence of the observed excess soil. The surface of the disturbed soil was uneven with several feet variation in height along the pipeline route. This indicates that final surface grading was not completed. It appeared, based on site assessment observations, that the pipeline had been installed between points B and C, but the pipeline installation was not consistent with contract requirements.

**Site photo 5: Uncapped submerged pipe end at point B**

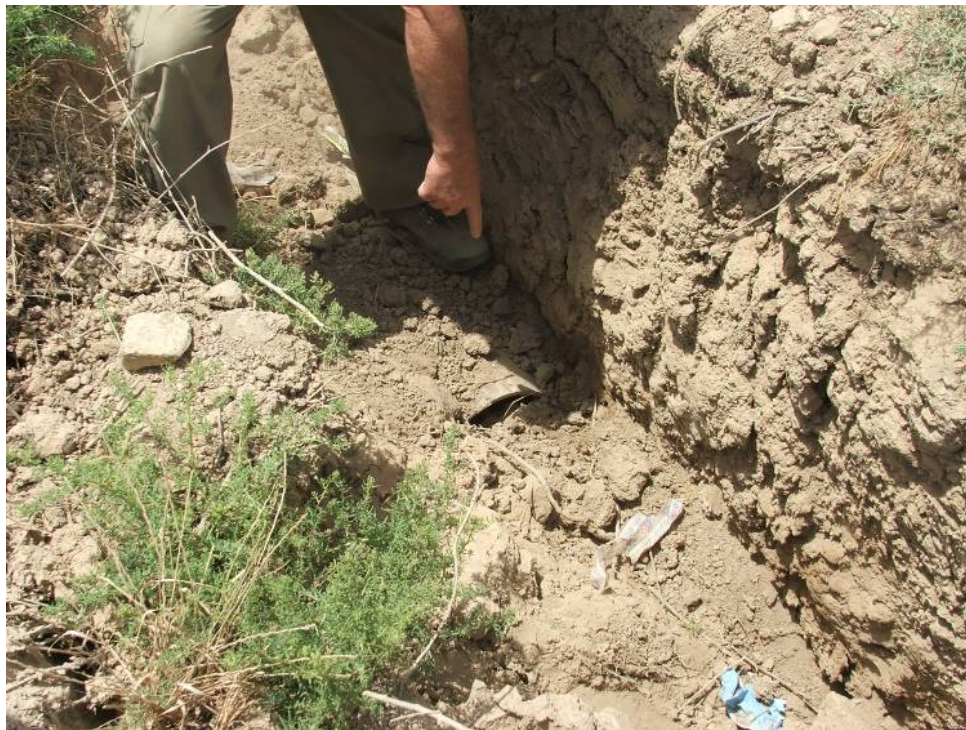
**Site photo 6: Uncapped pipe end at point C**

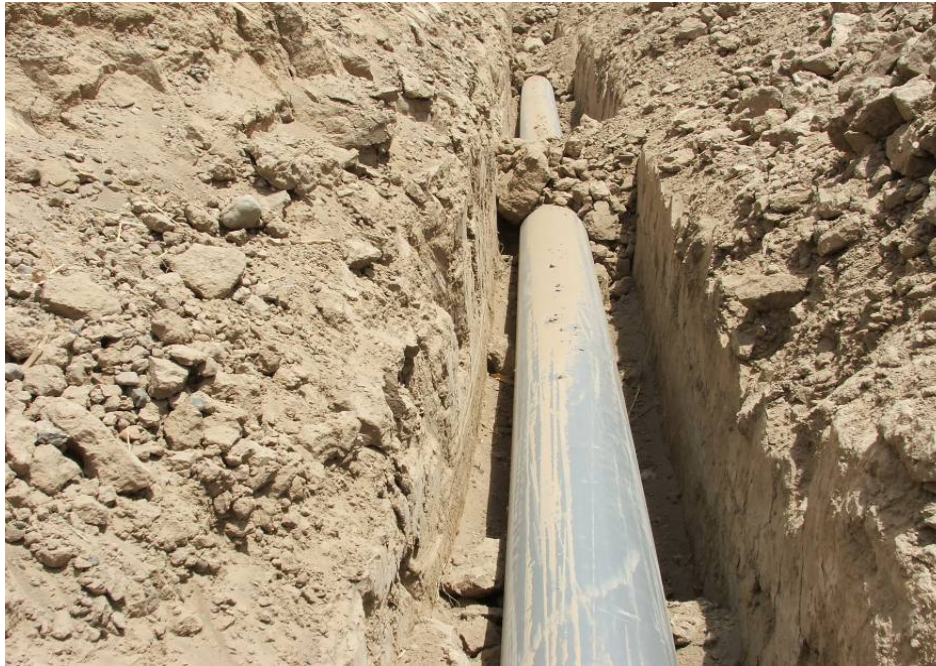
**Point F to G:** The pipeline leg from point F to point G (see the locator map in Figure 1 on page 4) is approximately 1,315 meters in length. Uncapped endpoints of a 225 millimeter pipeline were seen at both point F and point G. A short section of the pipeline trench, which was only partially backfilled, clearly indicated that sand base was not used (Site photo 7). Disturbed surface soil was observed along the remainder of the proposed pipeline between point F and G. The disturbed soil appeared to be the result of a recent trench excavation and subsequent backfilling of the trench. A significant amount of unconsolidated soil was observed above grade along the pipeline path. Lack of compacting during backfilling operations would result in the presence of the observed excess soil. The surface of the disturbed soil was uneven with several feet variation in height

along the pipeline route. This demonstrates final surface grading was not completed.

**Site photo 7: 225 millimeter pipeline in partially back filled trench**

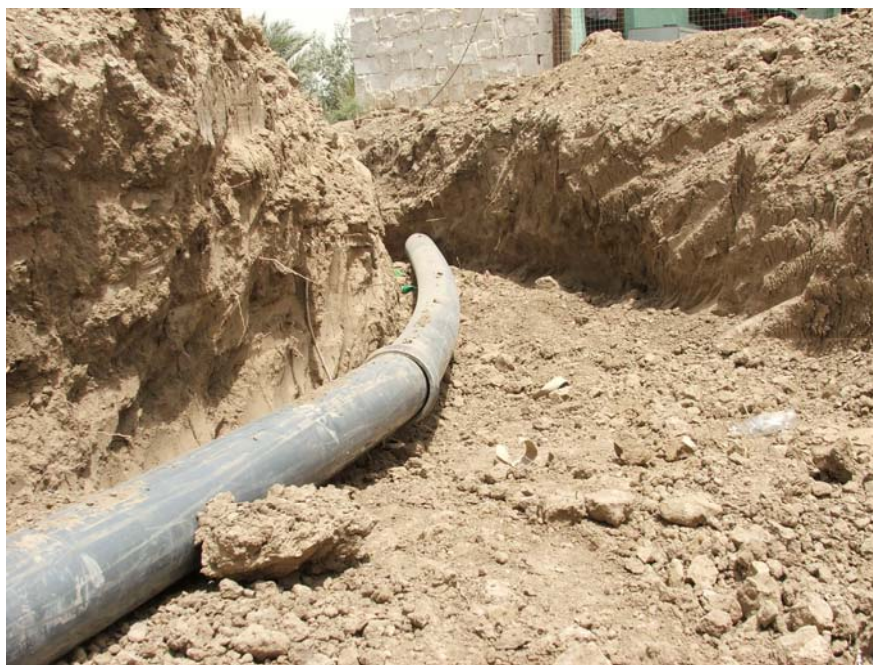
The pipeline near point G was observed to be routed around a bend without the use of an elbow fitting (Site photo 8), creating a 13 millimeter ( $\frac{1}{2}$  inch) gap in the pipe connection (Site photo 9). It appeared, based on site assessment observations, that the pipeline had been installed between point F and point G, but the pipeline installation was not consistent with contract requirements.

**Site photo 8: Bend in pipe**

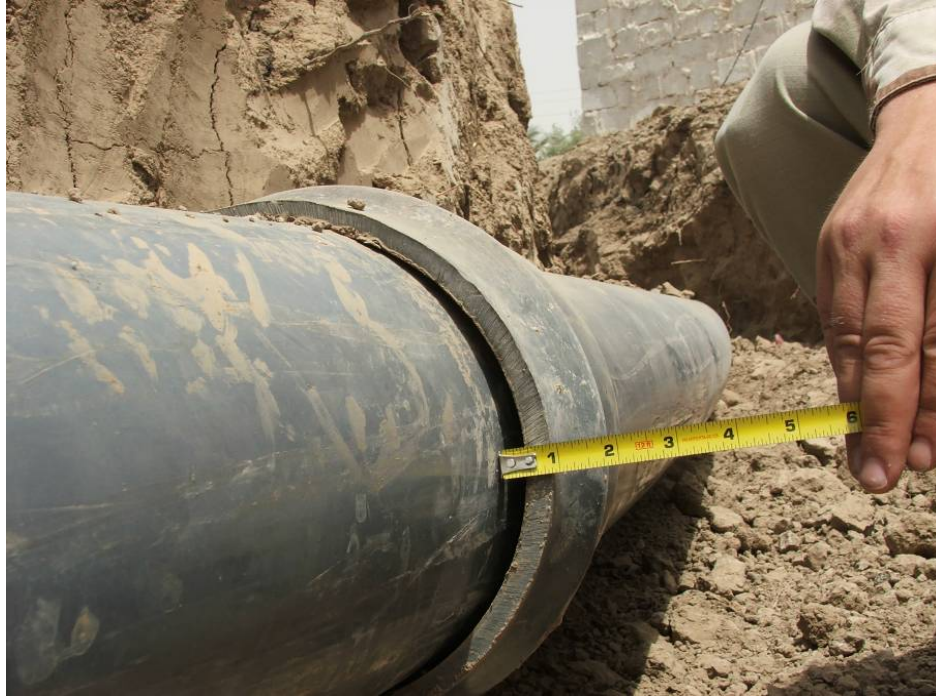
**Site photo 9: ½ inch (13 millimeter) gap in pipeline joint**
